Research Article

Evaluation of Data Extracted from Floor Plans for Apartment Complex Remodeling

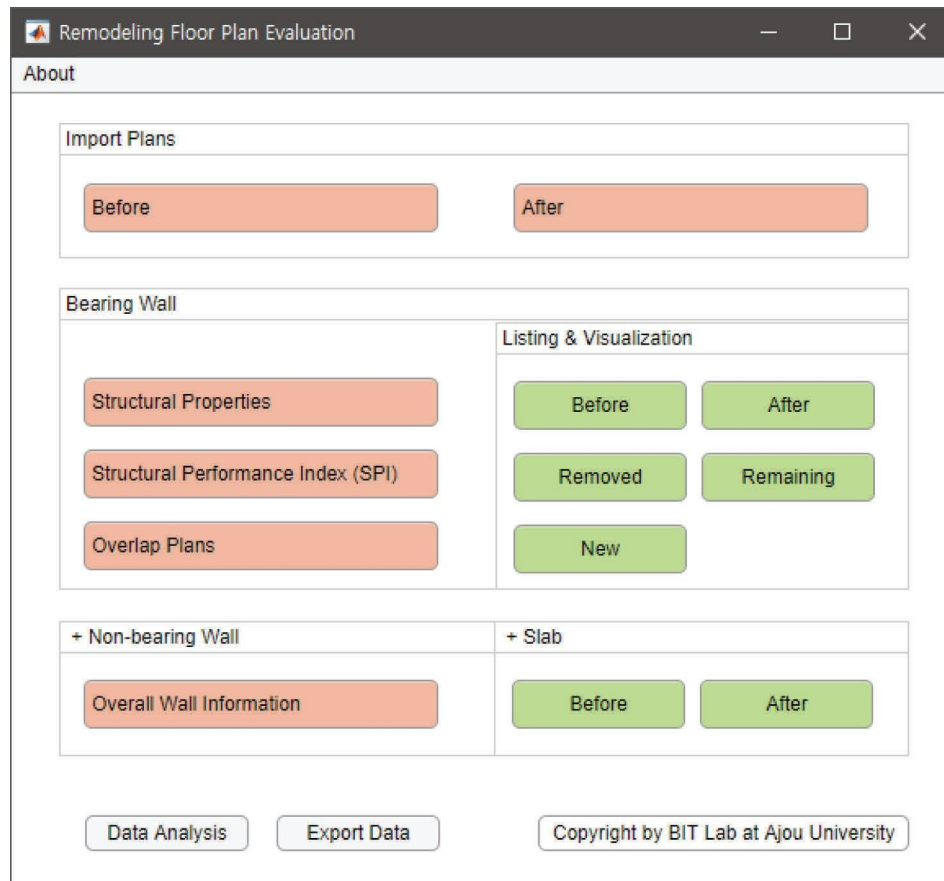
FIGURE 1: Graphical user interface of the developed program.

The program was developed in MATLAB (Math-Works) and operates according to the following flow: (1) preprocessing before and after remodeling plans based on CAD into image files; (2) importing, recognizing, and comparing the two image files; (3) computing parameters; and (4) reporting and visualizing. Figure 1 shows the main graphical user interface screen of the developed program. This program imports the preprocessed before and after remodeling plans using Import Plans buttons. Subsequently, the computing process proceeds by pressing the Structural Properties button. Based on the dimensional information obtained from floor plans, various parameters are calculated. Figure 2 shows a screenshot displaying the amount of removed, remaining, and new bearing walls, their rates and weights, area moment of inertia of walls (I_{xx} and I_{yy}), and torsional resistance of floor plans (geometry center, mass center, and the distance between two centers). A user inputs the wall height (m), longest dimension of the wall (m), and density of reinforced concrete (kg/m^3), and the program utilizes these inputs to convert the information of floor plans into physical dimensions. The longest dimension of the wall (m) refers to the actual length of the longest wall in floor plans. Furthermore, the developed program provides information related to the non-bearing wall,

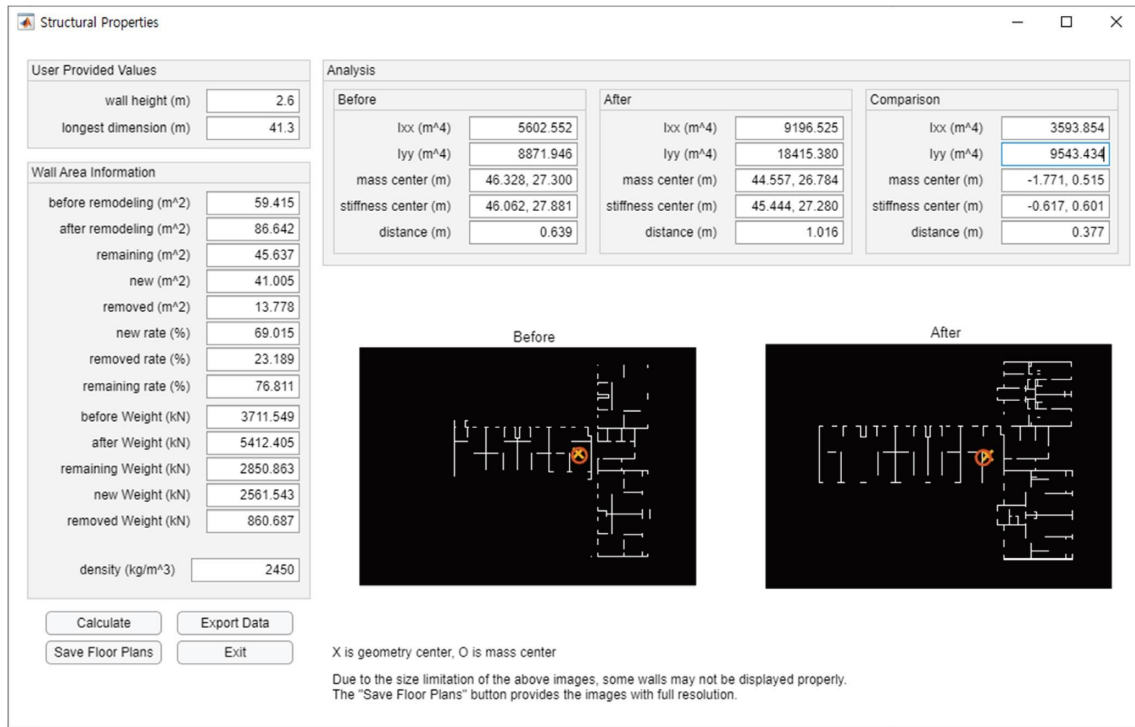
FIGURE 2: Automated floor plan evaluation.

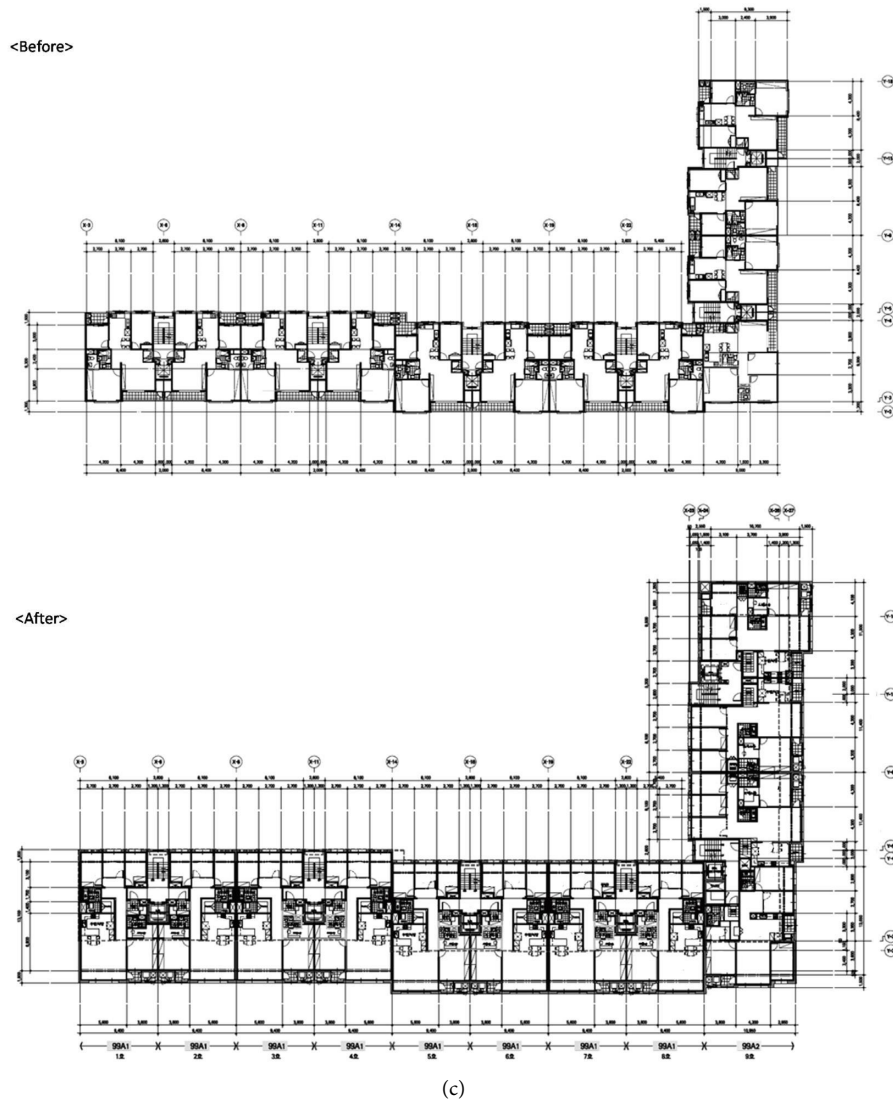
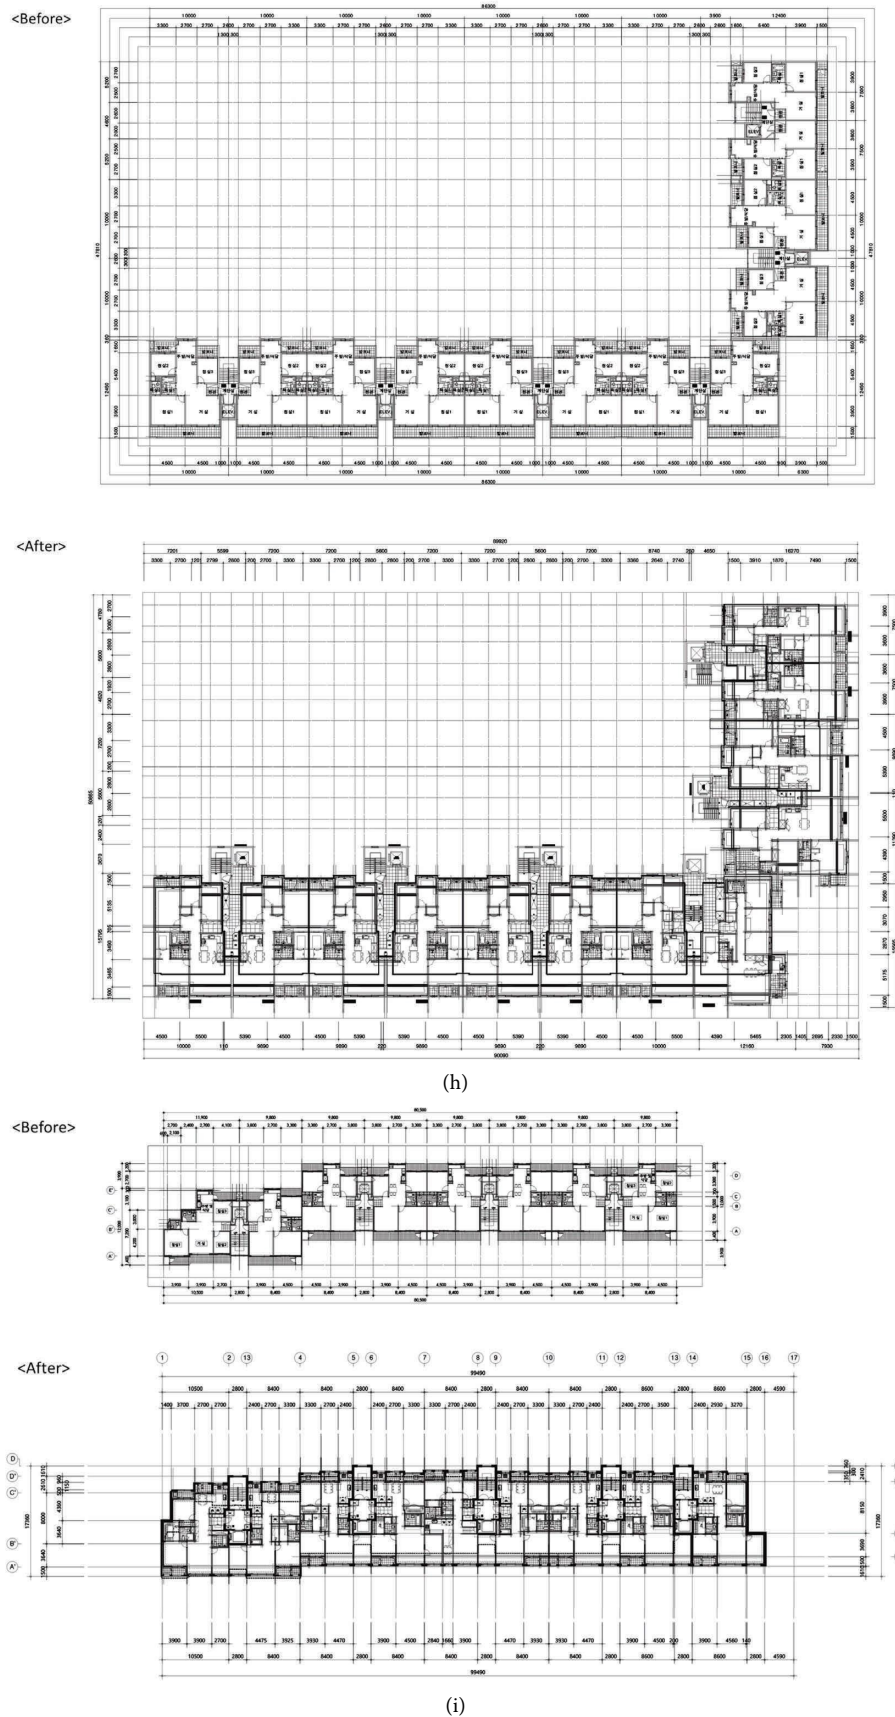
FIGURE 3: Before and after remodeling floor plans. (a) Building ID A, (b) Building ID B, (c) Building ID C, (d) Building ID D, (e) Building ID E, (f) Building ID F, (g) Building ID G, (h) Building ID H, and (i) Building ID I.

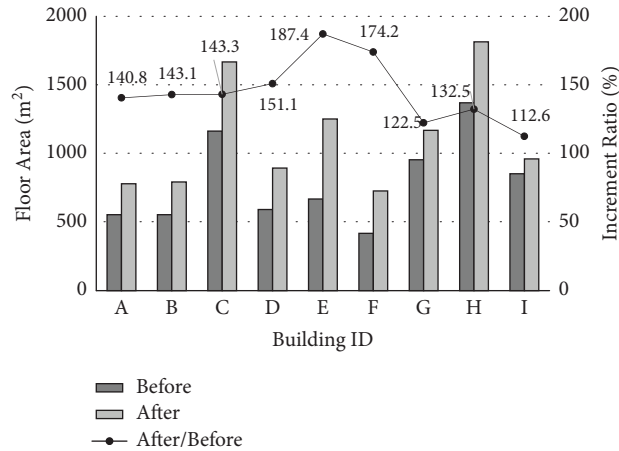
FIGURE 4: Floor area variation after remodeling.

horizontal expansion. Figure 4 compares the floor area variation of the nine apartment buildings analyzed after remodeling. After remodeling, the average floor area increased by 41%. The total area of Building ID E, whose increase in the total area was the largest, nearly doubled from 669 to $1,253 \text{ m}^2$, whereas that of Building ID I increased by 12% from 853 to 961 m^2 , indicating the smallest increase rate. Notably, the floor plan of each complex (Figure 3) shows that the number of units increased in the case of Building IDs E, F, and I, unlike Building IDs A–D, G, and H. When the number of units before and after remodeling is the same, the increment ratio shown in Figure 4 has a linear relationship with the expanded residential space of each unit; however, this is inapplicable in the case where the number of units has increased.

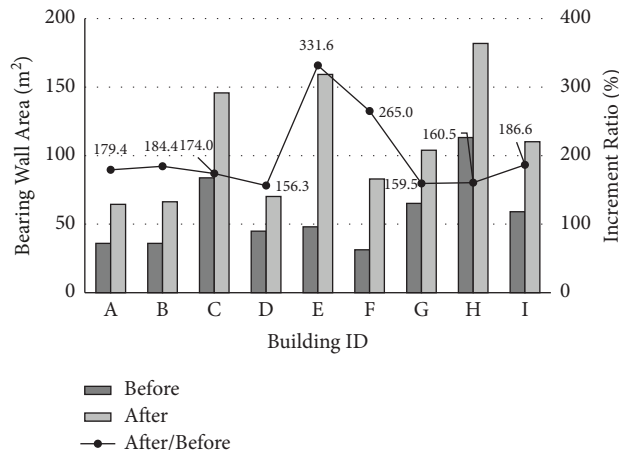
FIGURE 5: Variation of load-bearing wall areas after remodeling.

4.4. Area Moment of Inertia. Figure 11 compares the area moment of inertia of the x-directional and y-directional bearing walls to review the changes in the x-direction and y-direction stiffness before and after remodeling. The area moment of inertia of Building IDs A, B, D–F, and I with a relatively small bearing wall area (Figure 5) was determined to be low. In all cases, both I_{xx} and I_{yy} increased after remodeling. This is because the bearing wall area increased after remodeling. Because most of the domestic apartment houses are designed to be long in the x-direction, the area of the y-directional bearing wall is larger than that of the x-directional bearing wall, and I_{yy} is significantly larger than I_{xx} . Note that Building ID G has a larger x-directional bearing wall area than the y-directional bearing wall area (Figure 3(g)). As shown in Figure 3, Building IDs A, B, D–F, and I are typical apartment houses in the long form along the x-direction, while Building IDs C, G, and H have an extension along the y-direction. Interestingly, Building ID F had a long form along the x-direction before remodeling, while it underwent a floor shape change with an extension in the y-direction after remodeling. For these reasons, I_{xx} of Buildings IDs A, B, D–F, and I before remodeling is extremely low at an average of 478 m⁴, which is approximately 3.3% of the average I_{xx} of 14,641 m⁴ for the other three buildings (Building IDs C, G, and H). The average I_{xx} of the nine apartment buildings before remodeling is 5,199 m⁴, and the average I_{yy} is 26,243 m⁴, which is five times larger than I_{xx} . The average I_{xx} of the nine apartment buildings after remodeling is 11,332 m⁴, and the average I_{yy} is 54,451 m⁴, exhibiting an approximately twofold increase after remodeling. The highest area moment of inertia was found in Building IDs E and F, which may be attributed to the highest bearing wall area in Building IDs E and F after remodeling (Figure 5).

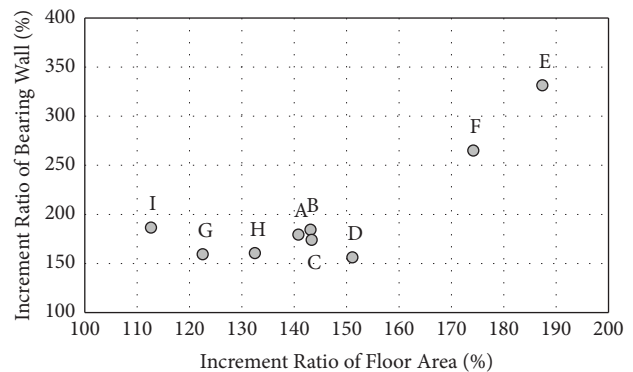
FIGURE 6: Relationship between increment ratios of the load-bearing wall and the floor area.

The rise in the floor area requires the increase in the load-bearing wall area to maintain structural performance. To determine the correlation between the size of the floor area and the proportion of the bearing wall, the relationship between the increment ratios of the load-bearing wall and the floor area for the nine apartment buildings after remodeling was plotted, as shown in Figure 6. The increase rate of the floor area was 113%–187%, while that of the bearing wall was 156%–332%, indicating that the bearing wall area-to-unit area ratio increased after remodeling. This result can be attributed to the application of the domestic seismic design code, which has become stricter since 2016. When the increase rate of the floor area was less than 160%, the increase rate of the load-bearing wall area was 156%–187%, whereas it sharply rose to more than 2.6 times when the increase rate of the floor area was 160% or higher (Building IDs E and F). As described previously, this result could be attributed to the increase in the number of bays in apartment Complex ID III after remodeling.

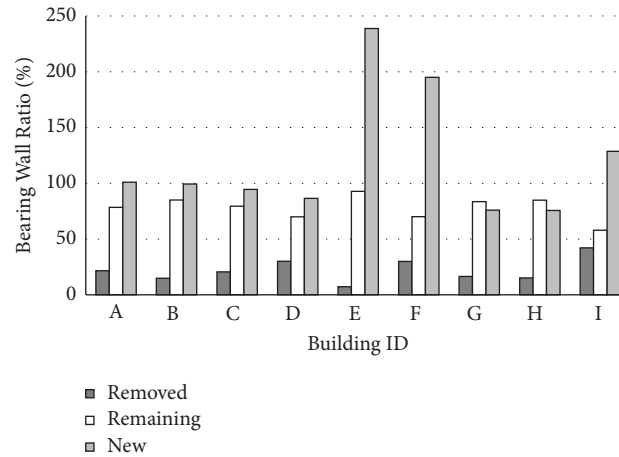
FIGURE 7: Ratio of removed, remaining, and new load-bearing walls after remodeling.

Table 3 and Figure 7 present the area of removed, remaining, and new bearing walls and their ratios with respect to the total bearing wall area before remodeling, respectively. An average of 22% of load-bearing walls were removed in the nine apartment buildings after remodeling, ranging from 7.2% (Building ID E) to 42.1% (Building ID I). The proportion of the remaining bearing walls was calculated to be 78.4% on average. The proportion of new bearing walls ranged from 75.7% to 238.8%, with an average of 101% for nine buildings. The highest proportion of new bearing walls was for Building IDs E (238.8%) and F (195.0%), which may be attributed to the increase in the number of bays.

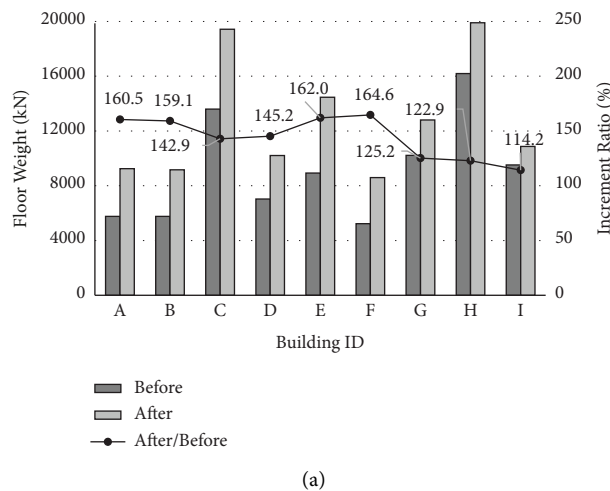
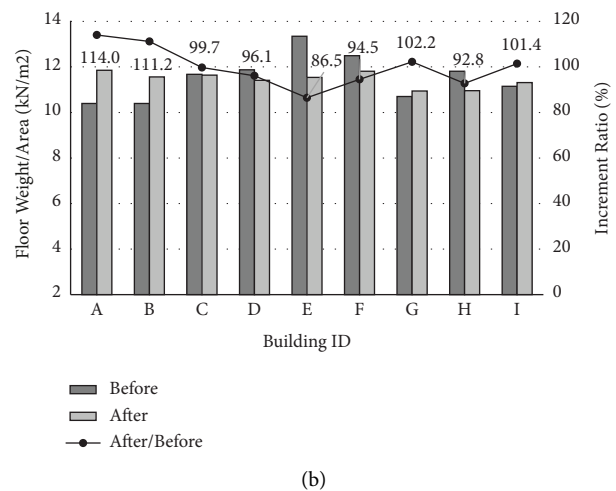
FIGURE 8: Variation of the floor weight and unit floor weight after remodeling: (a) floor weight and (b) unit floor weight.

10.4–13.3 kN/m^2 before remodeling and 10.9–11.9 kN/m^2 after remodeling, and its increment ratio was 86.5%–114.0%, indicating no significant change. This is because the floor weight after remodeling increased by an average of 39.5% for nine buildings, and the floor area increased by a similar proportion (41.1%).

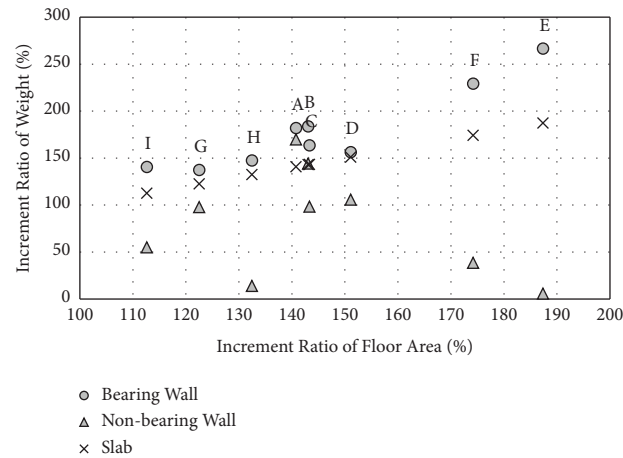
FIGURE 9: Relationship between increment ratios of the load-bearing wall, nonbearing wall, and slab weights and the floor area.

Figure 9 shows the relationship between the increment ratios of the load-bearing wall, nonbearing wall, and slab weights and the floor area. The analysis result indicates that the load increase rate of the load-bearing wall and slab has a proportional relationship with the increase rate of the total area. This is expected because horizontal expansion increased the areas of the slab and bearing walls, thereby increasing their weight. By contrast, because the nonbearing wall had a large deviation depending on the design of the space, there was no clear correlation with the increment ratio of the floor area. Among the nine apartment buildings, Building IDs E and F, which had an increased number of bays, exhibited the highest values for all indicators other than the increment ratio of the nonbearing wall weight.

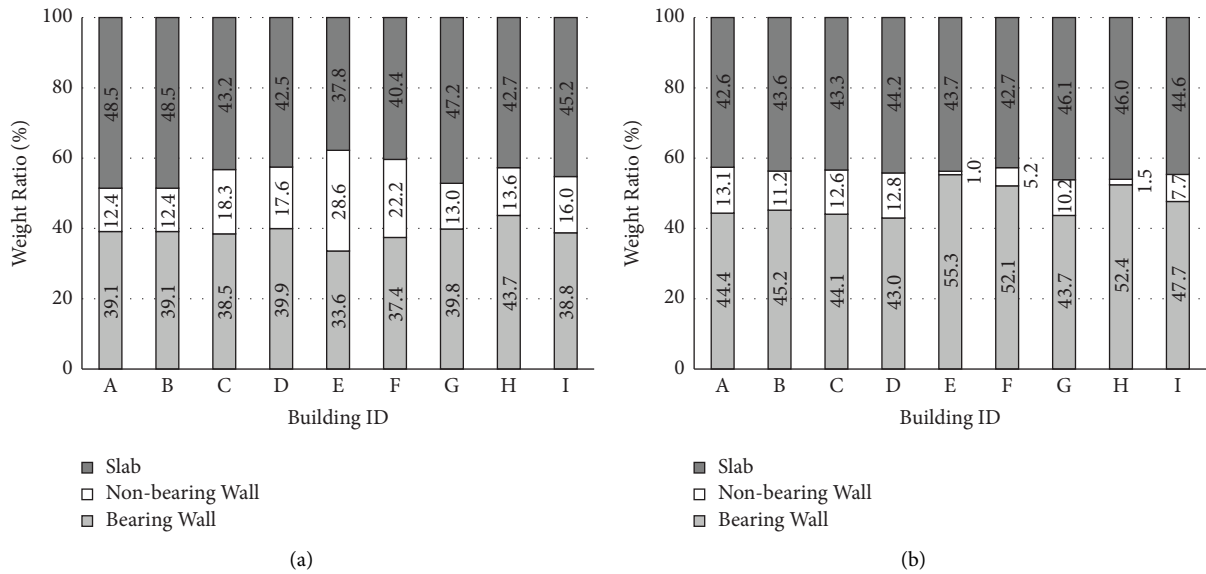
FIGURE 10: Floor weight ratio before and after remodeling. (a) Before remodeling and (b) after remodeling.

Figure 10 shows the ratios of the weight of the load-bearing wall, nonbearing wall, and slab (a) before and (b) after remodeling. The weight ratio of nonbearing walls exhibited a decreasing trend in all apartment complexes. The nonbearing wall weight, which accounted for an average of 17.1% of the floor weight, decreased to 8.4% after remodeling. The nonbearing wall weight of Building IDs A and B was the smallest at 12.4% before remodeling, while it was maintained at a similar proportion after remodeling. The

largest decrease in the nonbearing wall weight was found in Building IDs E and F, at 27.6% and 17%, respectively. Contrary to the case of nonbearing walls, the overall ratio of bearing wall weights increased after remodeling. The ratio of the bearing wall weight before remodeling was 38.9% as the average of nine buildings, while it increased to an average of 47.5% after remodeling. The ratio of the bearing wall weight for Building ID D was the smallest at 43%, and the bearing wall weight comprised more than half of the floor weight for Building IDs E, F, and G. In the case of the slab, there was no considerable change before and after remodeling. The increase in the ratio of the bearing wall weight was the highest in Building ID E (5.9%) and the lowest in Building ID A (6.0%). There was nearly no change in slab weight ratios in the nine buildings after remodeling, with an 8.7% decrease in the nonbearing wall and 8.7% increase in the bearing wall. Such changes indicate strengthened structural performance of the building after remodeling.

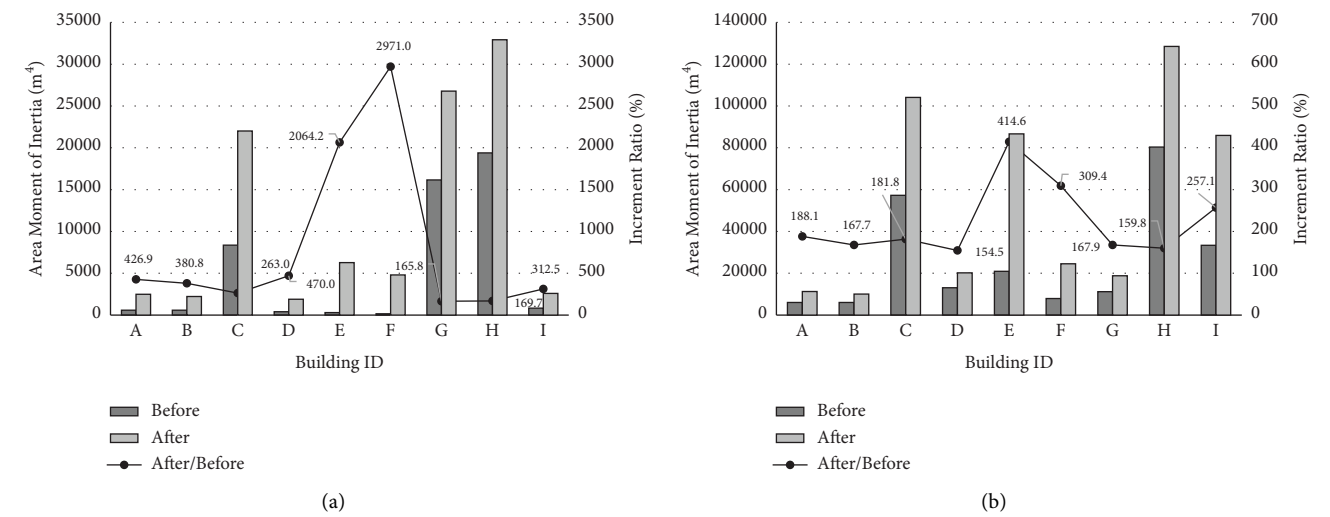
FIGURE 11: Variation of x - directional and y -directional area moment of inertia after remodeling: (a) I_{xx} and (b) I_{yy} .

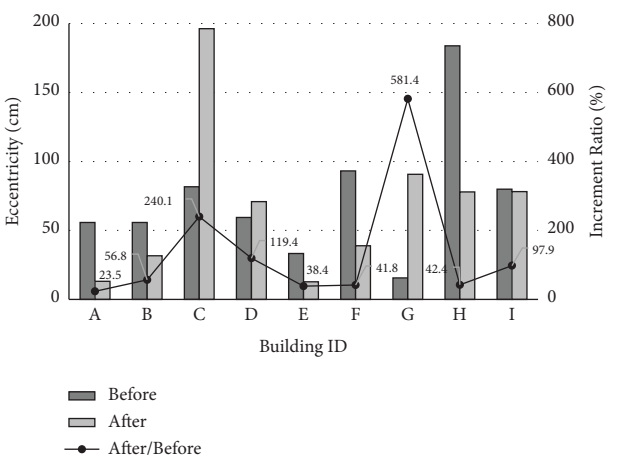
FIGURE 12: Eccentricity variation after remodeling.

eccentricity (distance between the centers of mass and geometry) and the amount of torsional deformation have a linear relationship. When eccentricity is large, the torsional resistance of the structure is disadvantageous because the structure is easily twisted even when subjected to a relatively small lateral load. Therefore, reviewing the centers of mass and geometry as well as the distance between the two is necessary. Figure 12 compares the nine apartment buildings in terms of eccentricity before and after remodeling. The calculated eccentricities of eight buildings before remodeling, except for Building ID H, were 100 cm or less. On the other hand, the eccentricity of Building ID H was 184 cm, which was considerably larger than that of the other eight buildings. The eccentricities of six buildings, except for Building IDs C, D, and G, decreased after remodeling. The largest decrease in the after/before rate was found in Building ID A, equivalent to the 1/4 level after remodeling. In addition, the eccentricity of Building ID H, which was the largest before remodeling, shrank to less than half, reaching 77.9 cm after remodeling. The eccentricities of Building IDs C, D, and G increased after remodeling; in particular, the eccentricities of Building IDs C and G increased by 2.4 and 5.8 times, respectively, after remodeling compared with those before remodeling.

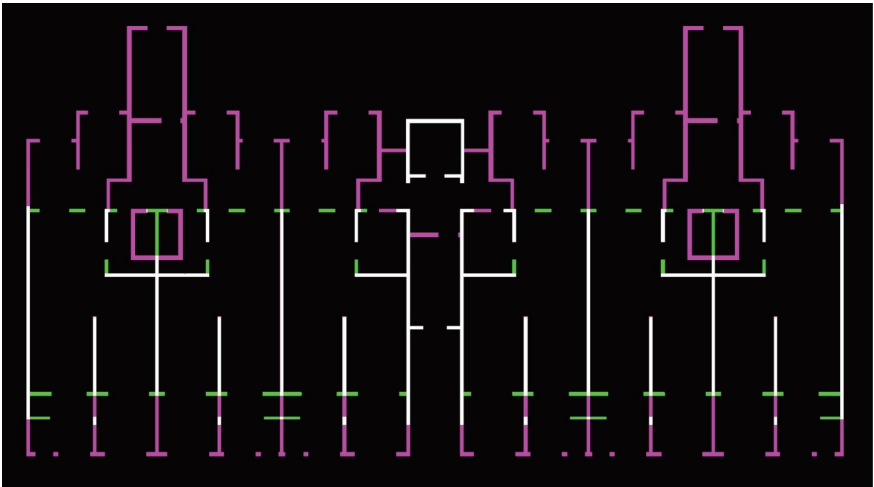
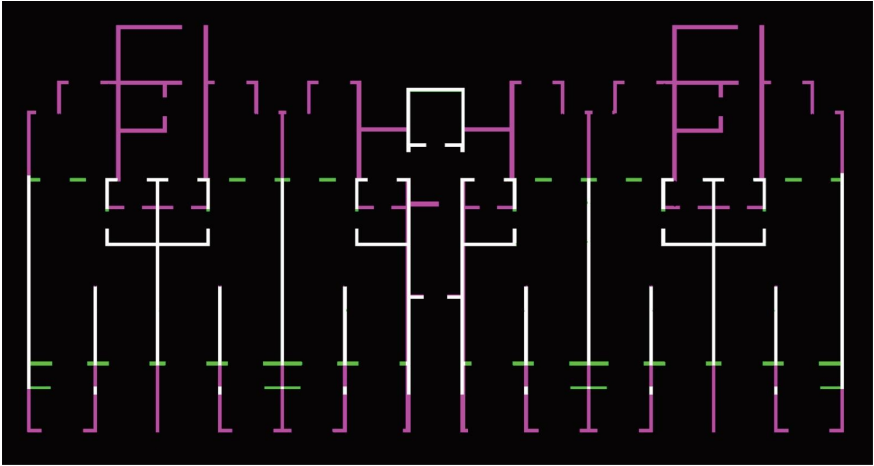
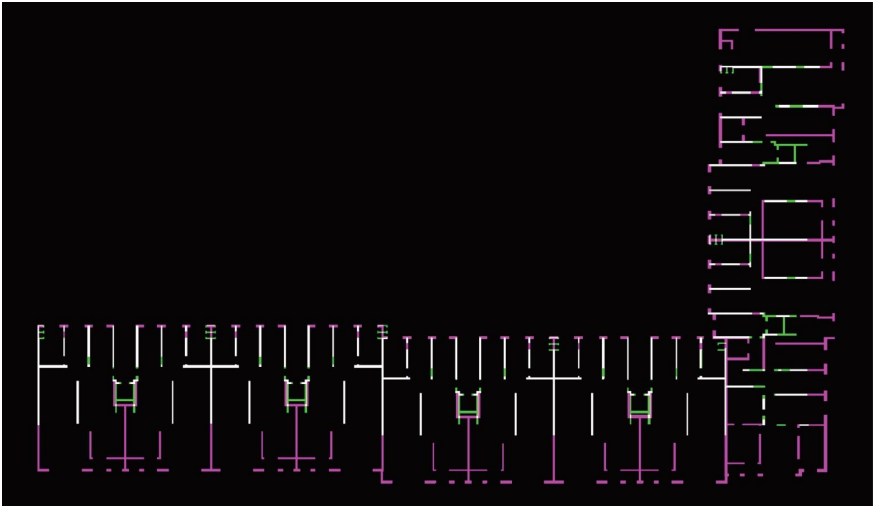
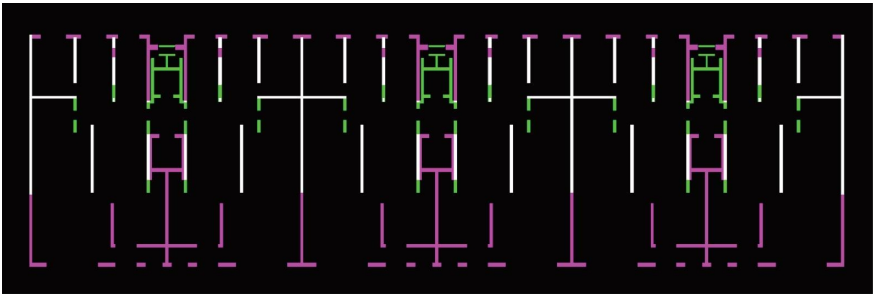
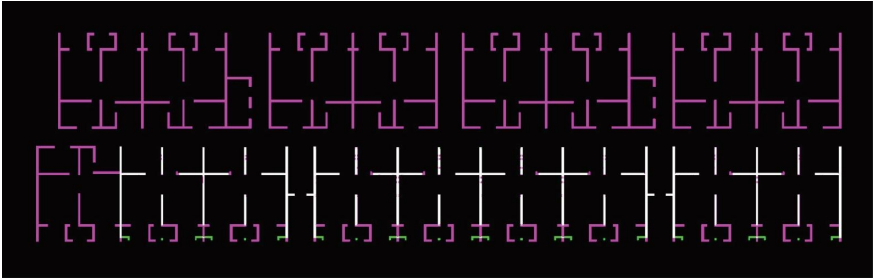
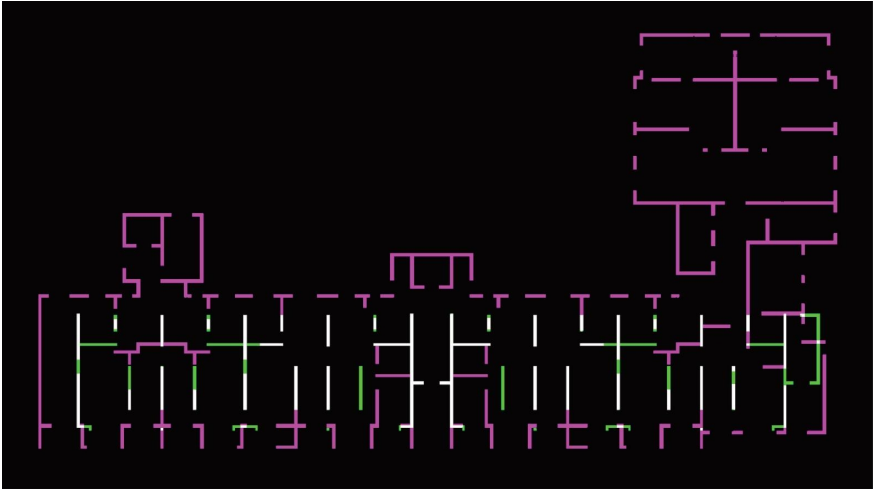
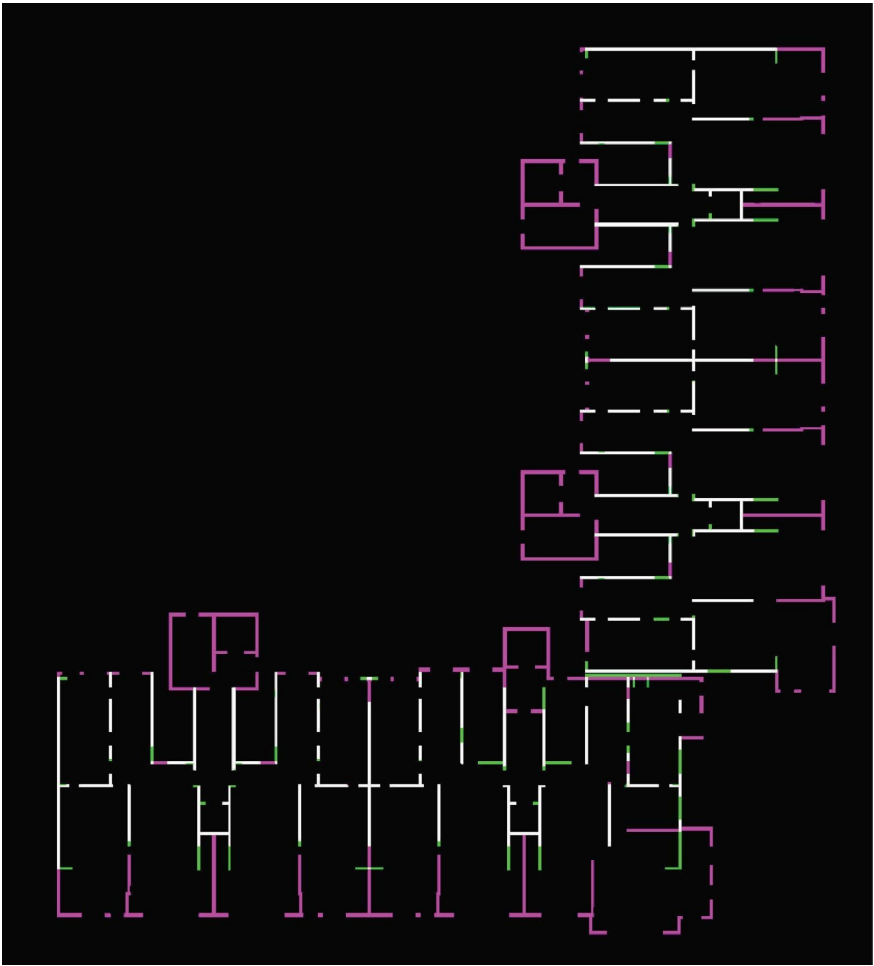
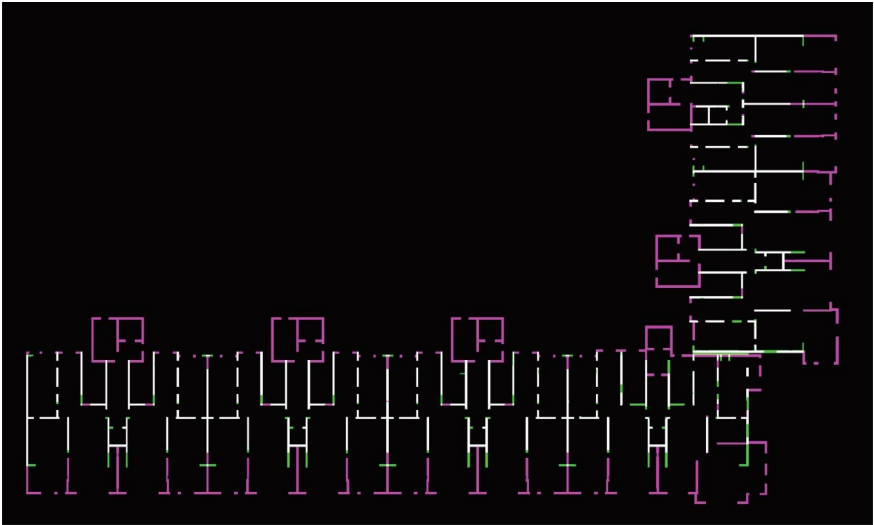
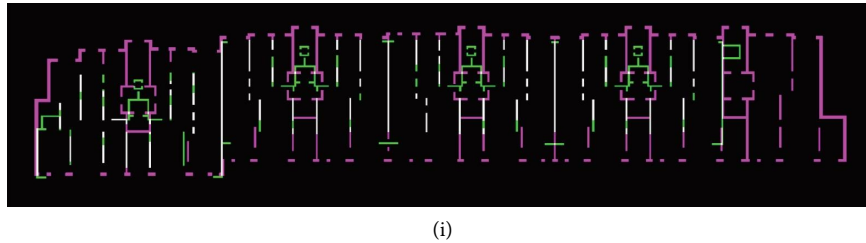
FIGURE 13: Overlapped and color-coded floor plans. (a) Building ID A, (b) Building ID B, (c) Building ID C, (d) Building ID D, (e) Building ID E, (f) Building ID F, (g) Building ID G, (h) Building ID H, and (i) Building ID I.

4.6. Visualization. The developed automated floor plan evaluation program includes a visualization function to intuitively compute changes in load-bearing walls before and after remodeling. Figure 13 shows the overlapped and color-coded floor plans of the nine apartment buildings;

green, white, and purple indicate removed, remaining, and new bearing walls, respectively. This function can intuitively visualize changes in bearing walls before and after remodeling as well as an addition of a core, further enabling the review of the thickness of bearing walls and possible errors associated with the locations of walls in floor plans. Figure 13 intuitively depicts the number of units incremented of Building IDs E, F, and I after remodeling and that the floor area increment and addition of load-bearing walls of Building ID E are the largest among nine buildings. In addition, Building ID F was changed from an I-shape to an L-shape after remodeling; in this regard, the location of the added bearing wall can be identified in detail.
